**Docket No. 217 – Development and Management Plan Inspection**

**Date:** January 22, 2004

**Location:** Norwalk Substation Expansion

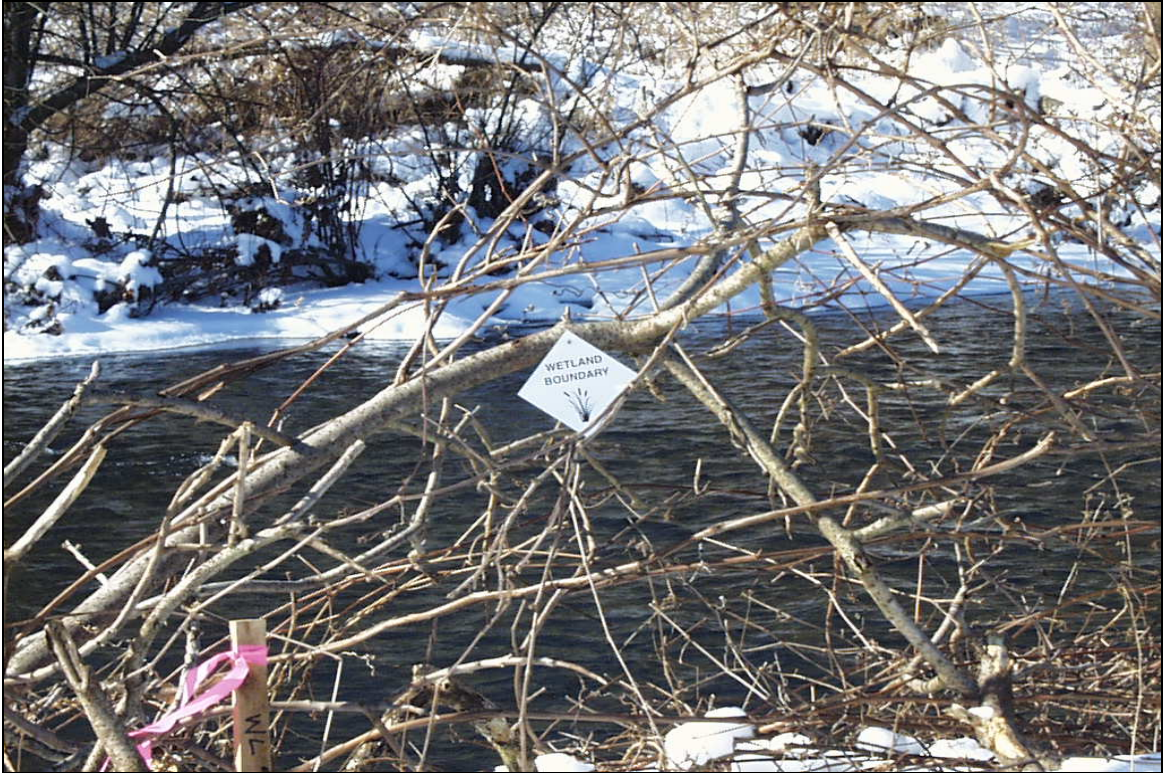
WETLAND BOUNDARY SIGNS WERE PLACED ALONG THE FLAGGED EDGE OF THE WETLAND RESOURCE AREA. NOTED 1/15/04

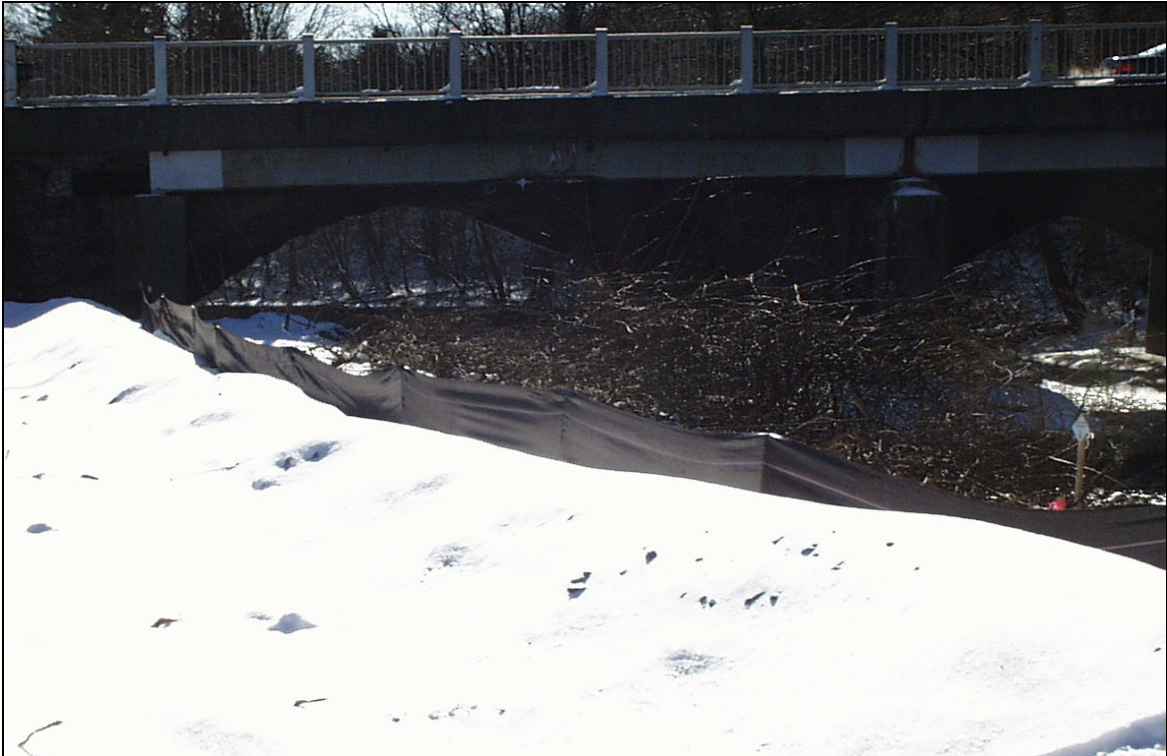
VIEW OF A NEWLY INSTALLED (SNOW COVERED) STONE BERM NEAR THE NORWALK RIVER. THE BERM WILL HELP TO STABILIZE AREAS NEAR THE BANK UNTIL SITE COMPLETION. 1/15/04

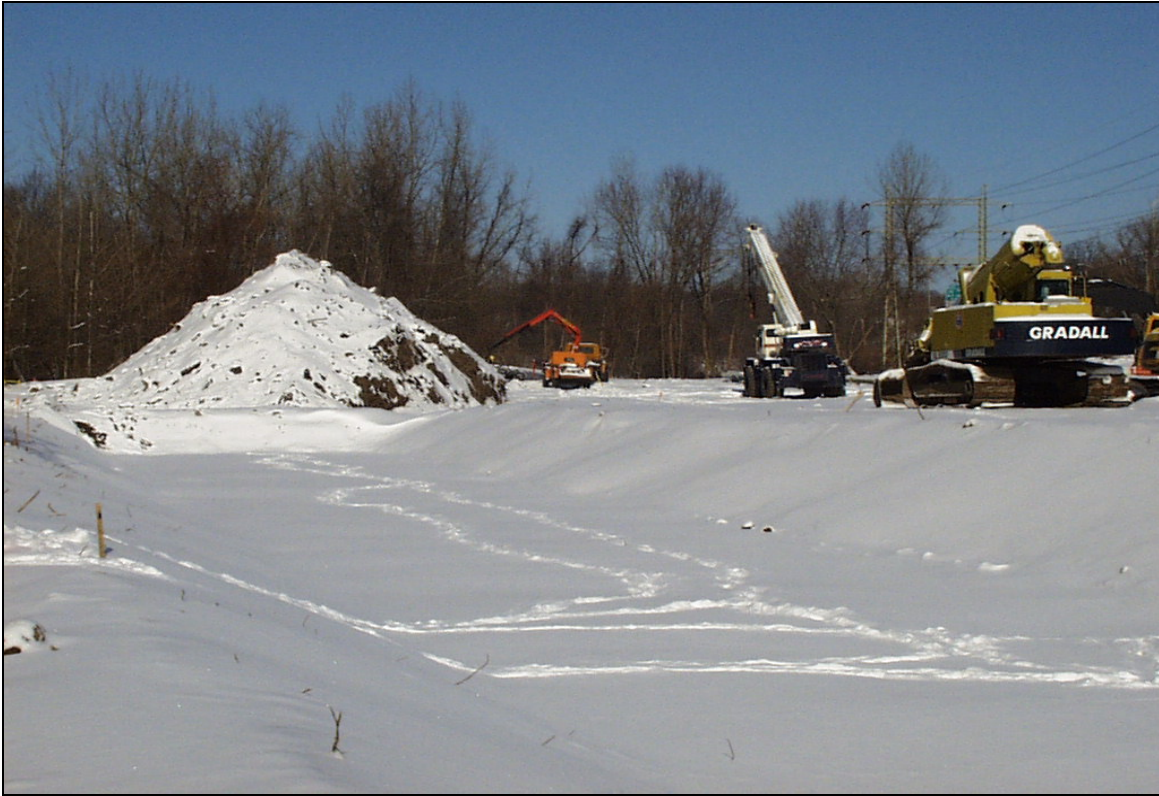
VIEW OF THE CONTINUING EXCAVATION FOR THE TEMPORARY SEDIMENT BASIN. THE BASIN IS ANTICIPATED FOR COMPLETION EARLY NEXT WEEK. 1/15/04

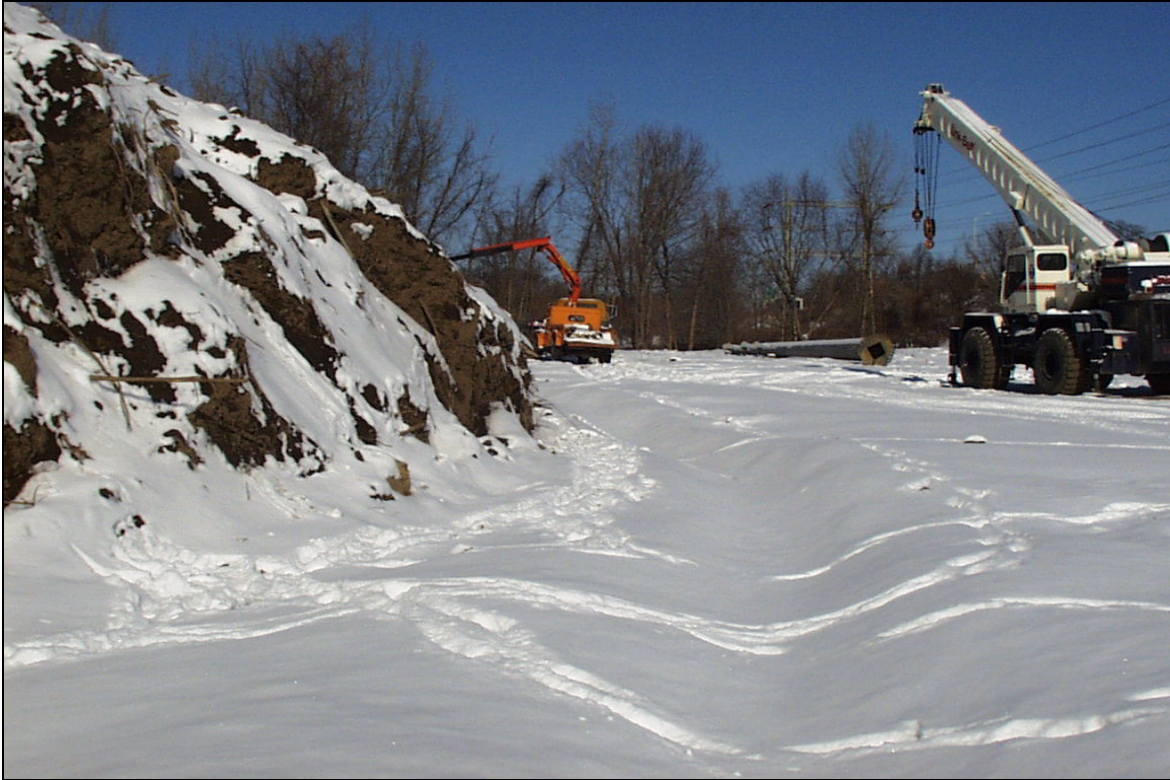
VIEW OF STONE SWALE WHICH WILL DIRECT DRAINAGE TO THE SEDIMENT BASIN. THE SWALE IS LOCATED NEAR THE BASE OF THE TOPSOIL STOCKPILE.  
1/15/04

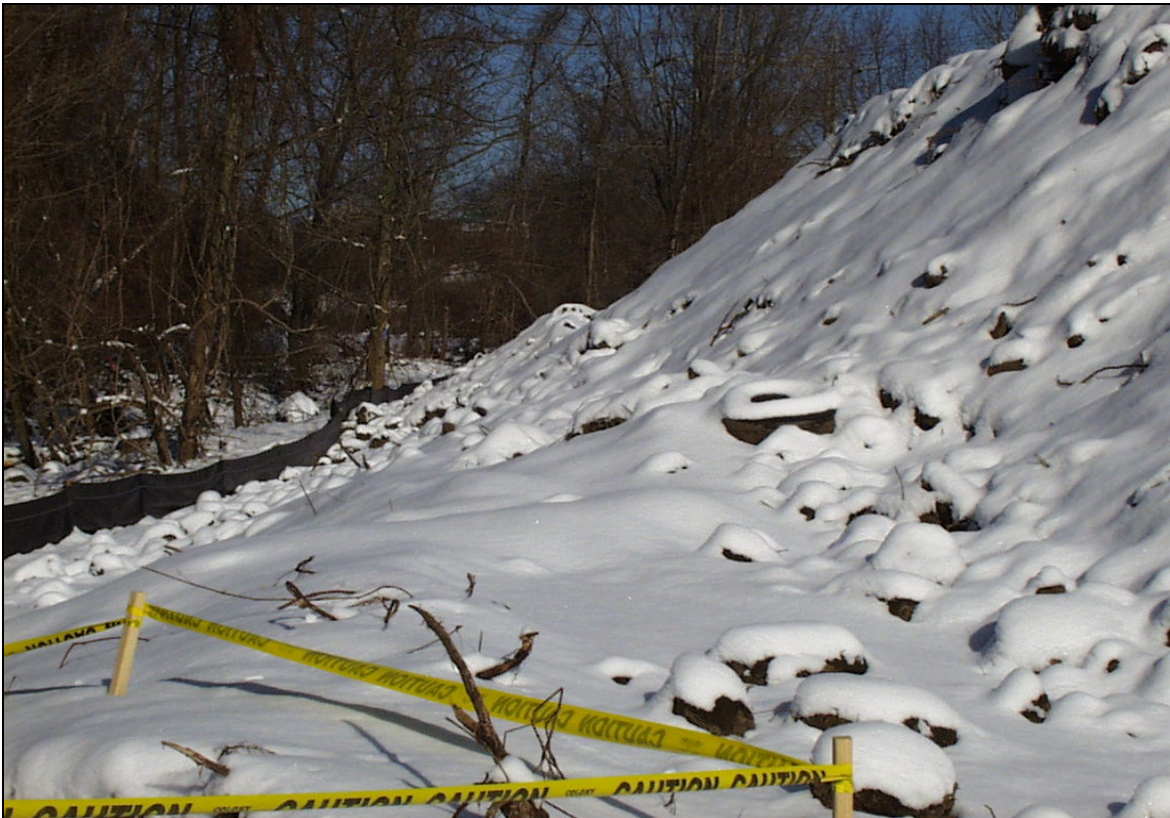
VIEW OF THE BACK OF THE TOPSOIL STOCKPILE ADJACENT TO THE PERIMETER SILT FENCE. A SECOND SILT FENCE IS RECOMMENDED FOR INSTALLATION AT THE BASE OF THE STOCKPILE PRIOR TO ANY THAWING TRENDS OR RAIN EVENTS.  
1/15/04
